CPA Funding – FY2020 Final Application

Arlington Housing Authority
Building Envelope Repairs, Window Replacement, Phase 1
Winslow Towers 667-3, Elderly Housing
Schematic Report and Recommendations

Re: Winslow Towers Condition Assessment - DRAFT
WJE No. 2017.6855

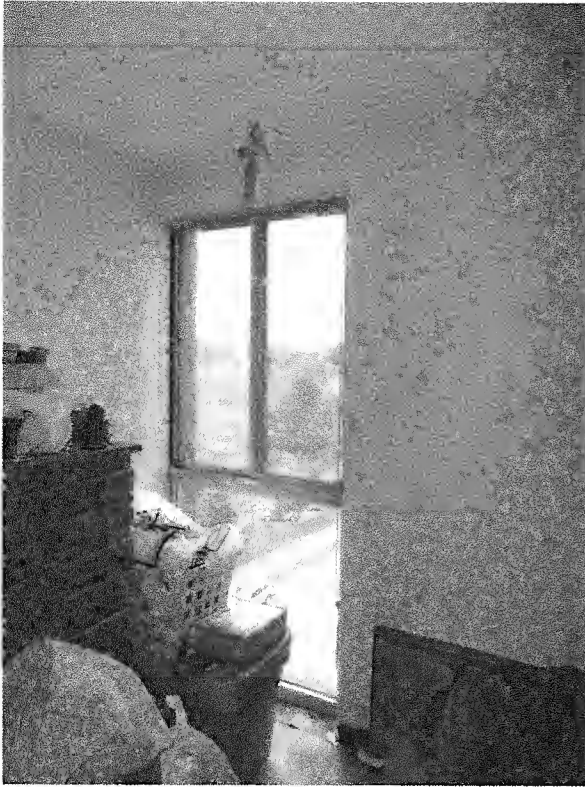
Figure 59. Water observed on ceiling in bedroom of unit 902

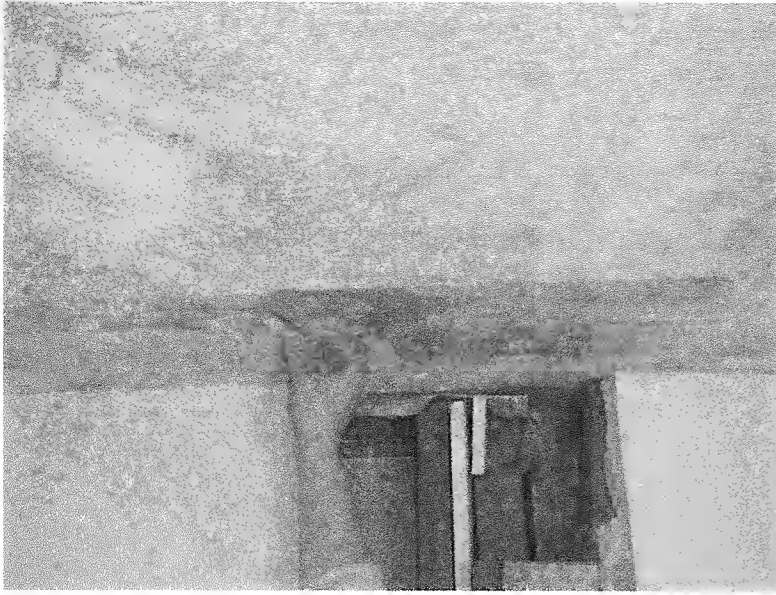
Testing was subsequently performed at the vertical sealant joint along the interface between the concrete wall and the masonry infill wall at the building corner. The third test started at this vertical corner sealant joint, starting at the soffit of the twelfth-floor concrete perimeter beam (immediately above the eleventh-floor window level). During this test it was reported that there was water infiltration at Unit 902, two floors below. Testing was temporarily stopped. Water infiltration was observed at the ceiling adjacent to the bedroom window in Unit 902 (Figure 58 and Figure 59). Testing restarted at the vertical sealant joint. Testing was performed by spraying water up the vertical sealant joint, moving the nozzle at a speed of 1 LF/minute (Figure 60). After 15 minutes, water was observed at the ceiling, at a concrete crack approximately two feet from the exterior wall (Figure 61). As the test continued, the water infiltration moved further into the interior along the concrete crack (Figure 62). The test was concluded after approximately 30 minutes. Water continued to enter at the ceiling even after the water was shut off.

Figure 61. Water leakage on ceiling in the living room of unit 1102 following spraying of exterior vertical sealant joint (indicator paper turns pink upon water contact)

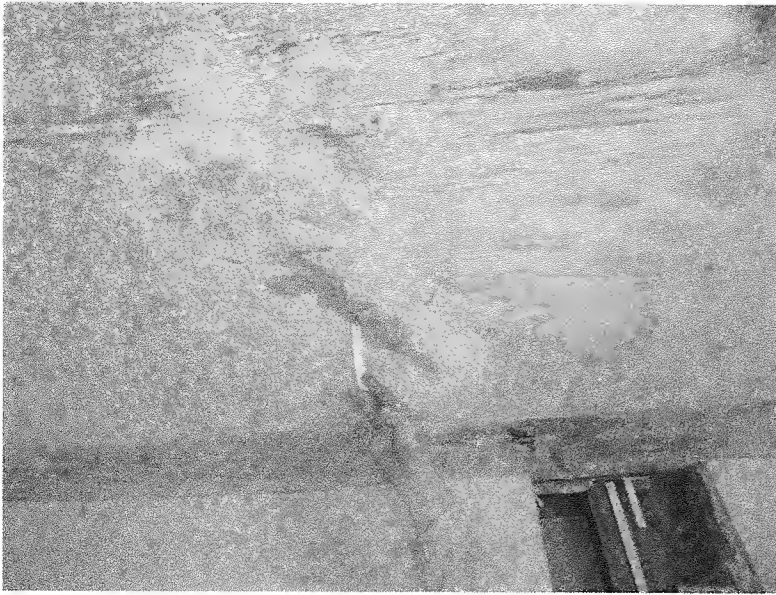
Figure 62. Greater water leakage on ceiling in the living room of unit 1102 following spraying of exterior vertical sealant joint (indicator paper turns pink upon water contact)

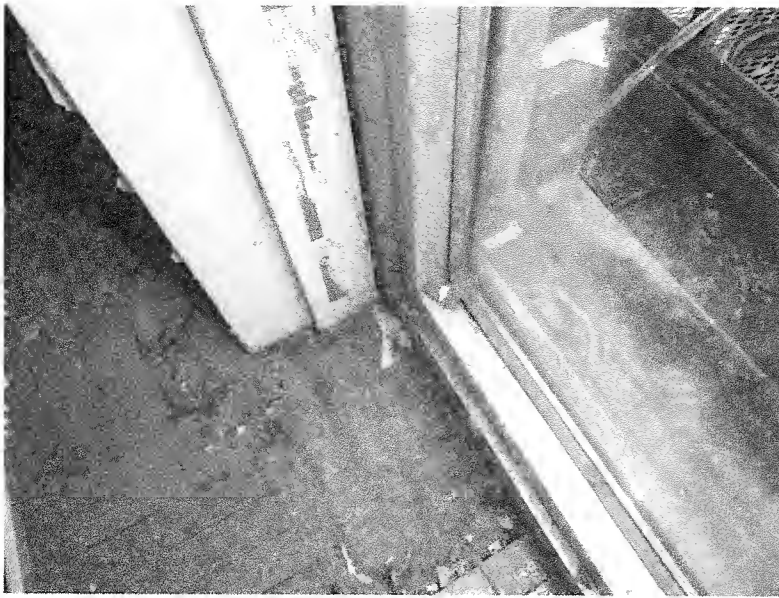
Subsequent testing at the fourth location was at the facade corner at the living room. Initial testing at this location focused on the floor line and the window sill. Testing was performed by spraying water along the floor line at the interface of the concrete perimeter beam and brick infill above, moving the nozzle at a speed of 1 LF/minute towards the window (Figure 63). Testing ended at the window sill flashing when water was observed at the interior at the floor (Figure 64). Parquet flooring was removed to better observe the water infiltration. Water continued to enter below the living room window even after the water was shut off. Voids in the sealant at the window sill were noted during the testing (Figure 65 and Figure 66). Additional testing (Test No. 5 in Table 1) at the concrete perimeter beam flashing (below the beam) in the same area did not result in any additional water infiltration (Figure 67).

Figure 64. Water infiltration observed at window in living room of unit 1102 (indicator paper turns pink upon water contact)

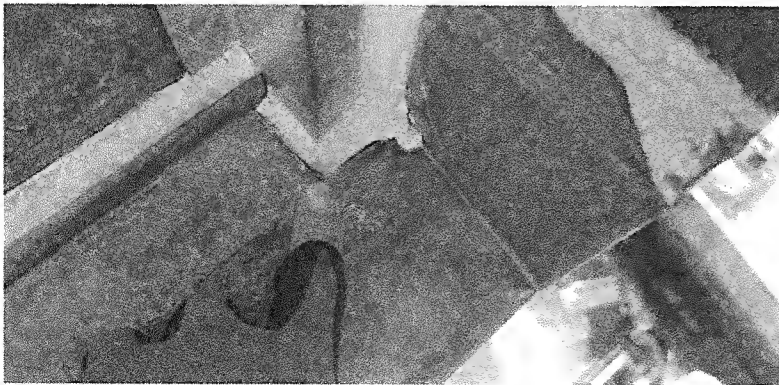
Figure 65. Void in sealant at window sill of living room window of unit 1102

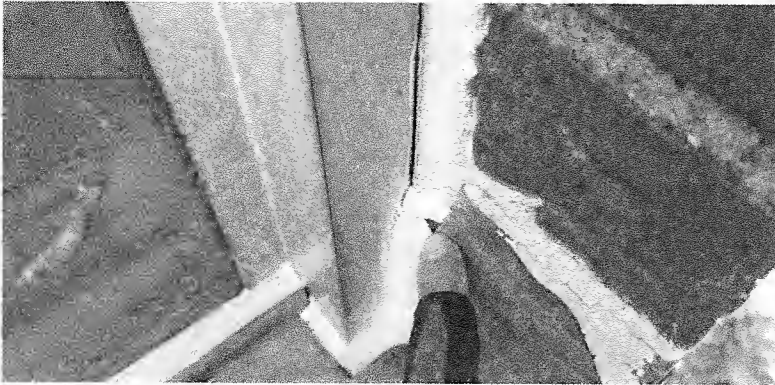
Figure 66. Void in sealant at window sill of living room window of unit 1102
